ANALYSIS OF IMPROVEMENT CAUSING DAMAGE TO CYLINDER LINERS AND PISTON RODS IN VEHICLE MODELS (F65 # -3SZ)

ENSAINS: Vol. 2 Nomor. 2 Mei 2019

Cecep Deni Mulyadi¹
Universitas Sangga Buana
Email: denicecep30@gmail.com

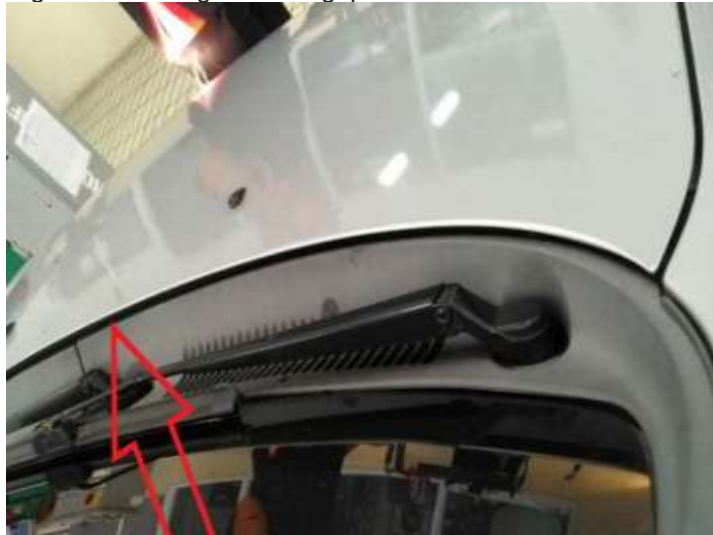
1. Rain water enters through the rear engine hood gap

Figure 4 Rear Hood Engine Slits (Source: 2018 research documentation)

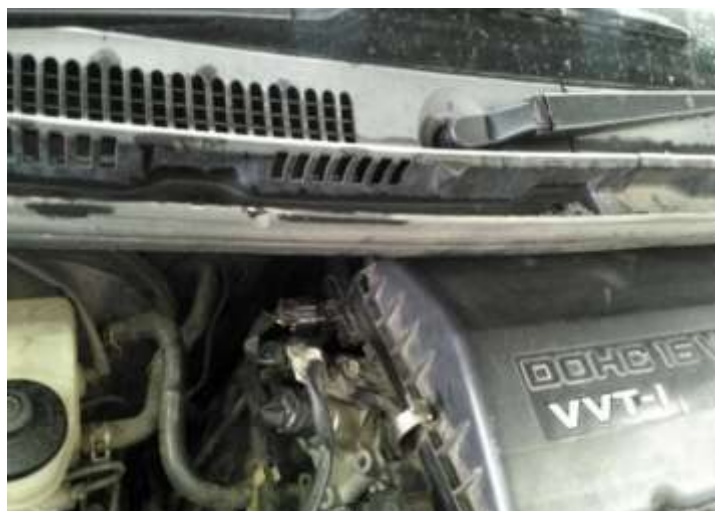
2. Then the water enters through the gap between the seal cowl and cowl

Figure 5 Seal Cowl (Source: 2018 research documentation)

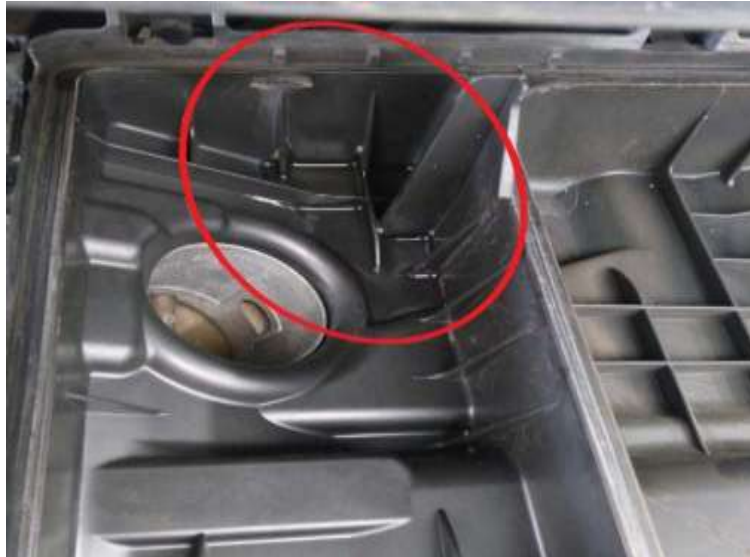
3. Because the air filter assembly has not been repaired, there is a gap in the water filter assembly

Figure 6 Gap in Air Filter (Source: 2018 research documentation)

4. Because of the water that is pooled in the water filter assembly, the water enters the intake manifold due to the vacuum and then goes into the combustion chamber and a water hammer occurs.

3. Improved air filter assembly

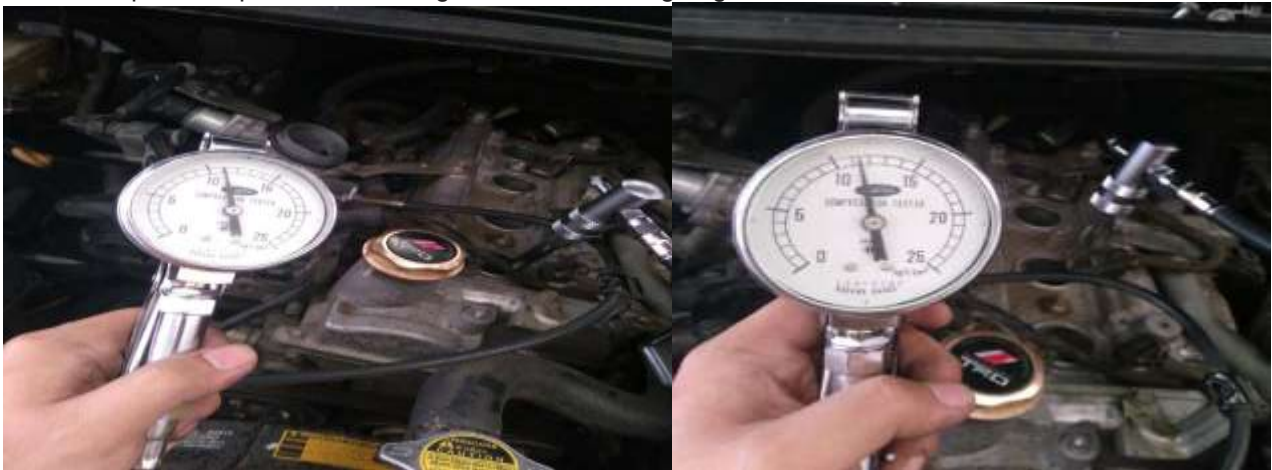
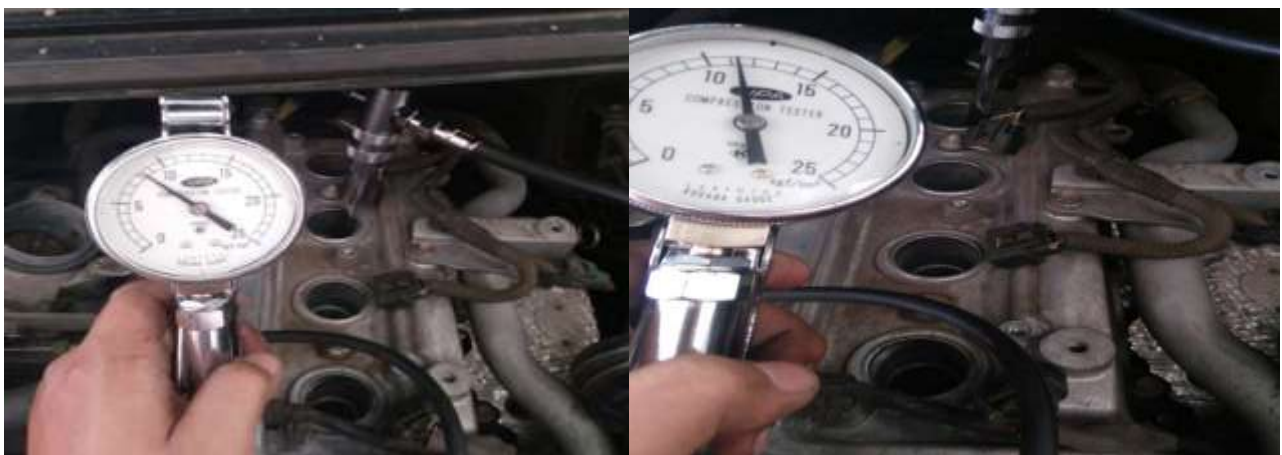
Figure 7 Results of Compression Pressure Checks on Cylinder & Pressure Compression Checks on Cylinder (Source: 2018 Research Documentation)

Figure 8 Results of Pressure Compression Checks on Cylinder & Results of Pressure Compression Checks on Cylinders (Source: 2018 Research Documentation)

From the results of the examination carried out it can be seen that the compression pressure on cylinder No. 3 is less than the specified specification. Where the specifications of compression pressure on vehicle models (F65 # -3SZ) are:

Standard pressure: 1470 kPa (15.0 kgf / cm², 213 psi) Minimum pressure: 1079 kPa (11.0 kgf / cm², 156 psi)
The difference between each cylinder: 147 kPa (1.5 kgf / cm², 21 psi)
After it was known that the compression pressure on cylinder No. 3 was less than the standard drinking compression pressure which ranged from 8.2 kgf / cm² it was decided to overhaul the engine.

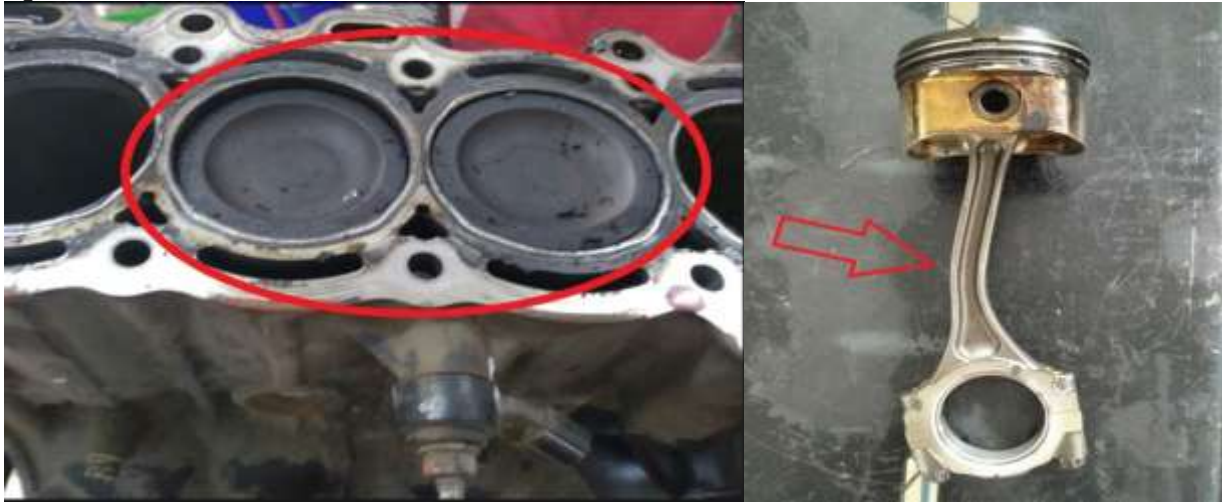
Figure 9 Difference in Torque Height when Upper Dead Point & Damage to the piston rod due to water hammer (Source:2018 Research Documentation)

As a result of the damage that occurs to the piston rod causing a collision between the piston rod and the lower cylinder liner, causing a cylindrical liner to be defective.

2. Replacement of piston rod and piston fittings is carried out.

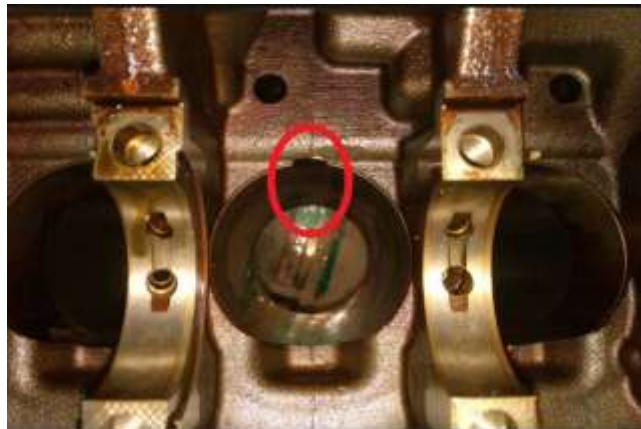
Figure 10 Damage to the piston rod due to water hammer (Source: 2018 Research Documentation)

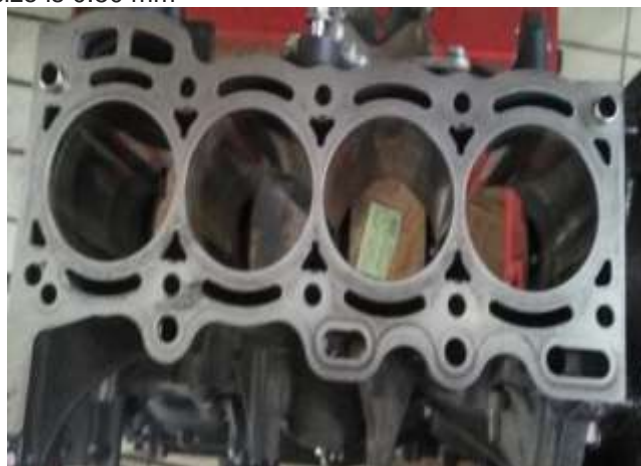
Figure 11. Cylinder Block After Oversize (Source: 2018 Research Documentation)

1. In the cylinder liner over size is 0.50 mm

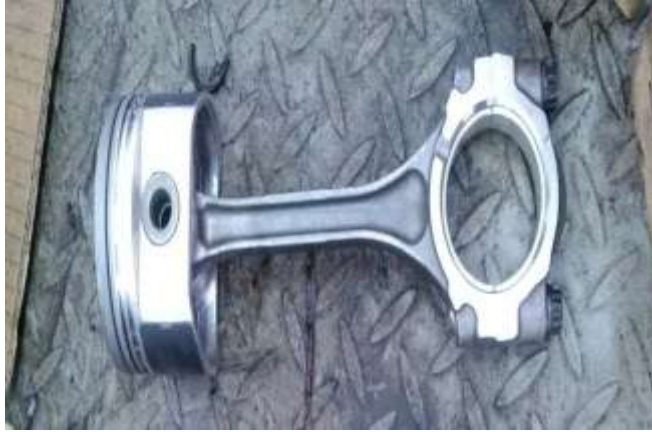
Figure 12 Torque and Torque Rods after replacement (Source: 2018 Research Documentation)

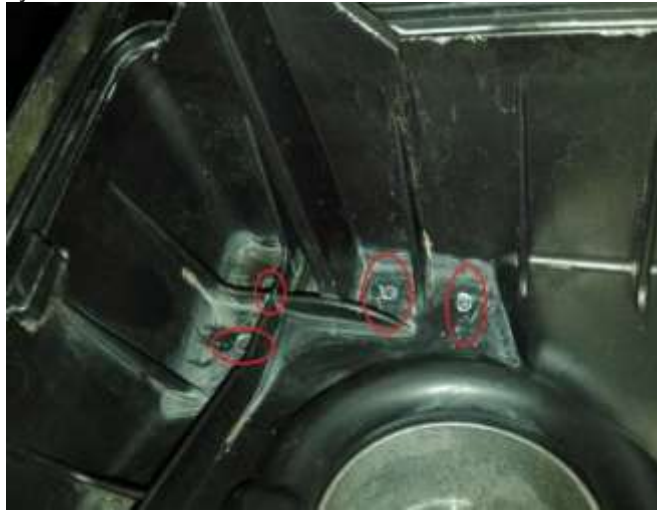
Figure 13 Air Filter Assembly After Improvement (Source: 2018 Research Documentation)
